Circular No. 61 / 2024

Field Safety Notice of IQon, iCT, Ingenuity, and Brilliance CT 64 systems from Philips Medical Systems.

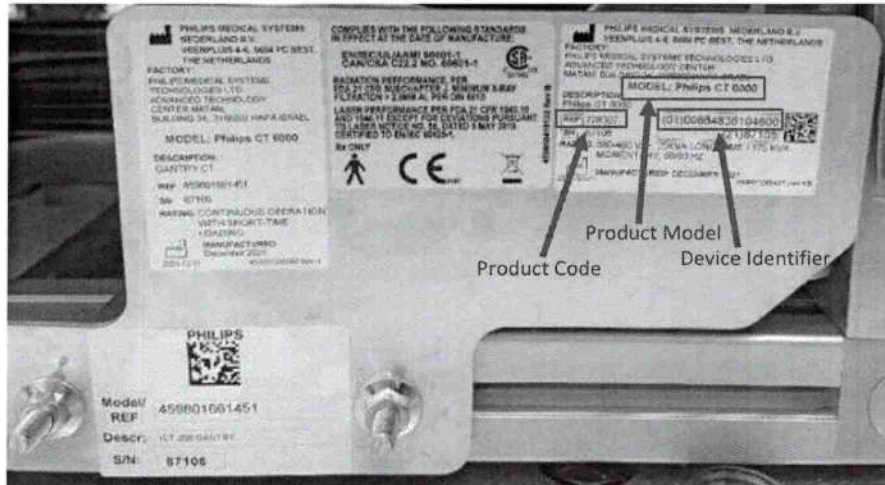
Figure 1. Example system label

1. Identify the product model name and product code on the back of the gantry in the bottom right corner as shown in Figure 1.
